Advanced Manufacturing Development of a Composite Empennage Component for L-1011 Aircraft

QUARTERLY TECHNICAL REPORT NO. 11

For the period 1 July 1978 through 30 September 1978

Lockheed Corporation
Lockheed Martin Company
P.O. Box 100
Burbank, California 91500

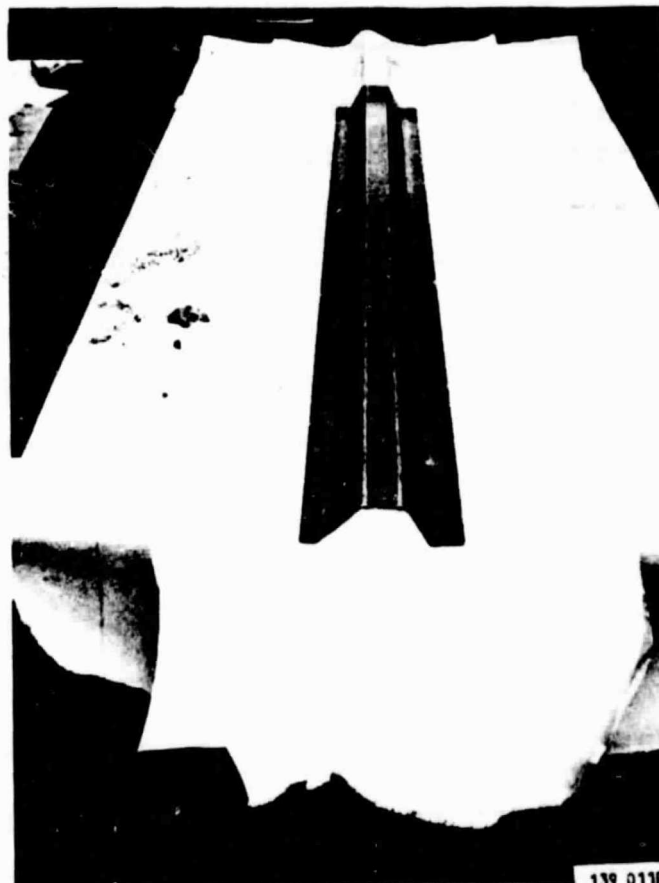
Figure 2-2. Hat Assembly with Air Bleeding Materials and Steel Caul

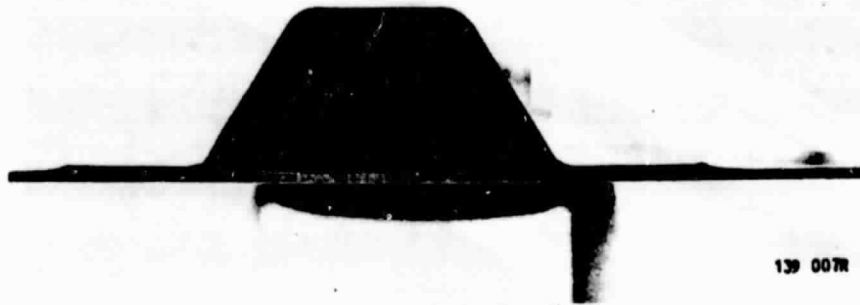
139 007R

Figure 2-5. Cross Section of Hat-Stiffened Panel

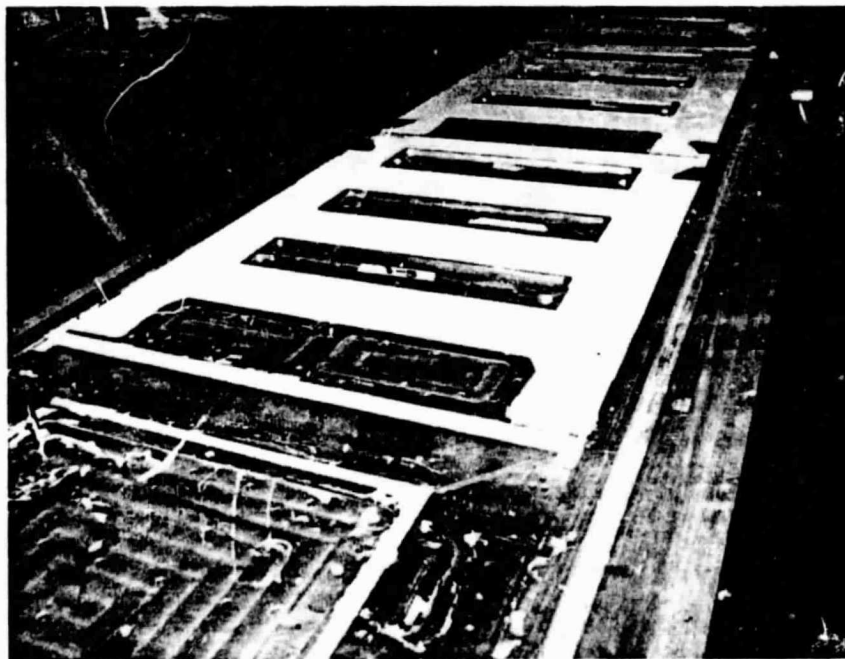
RL 3796-14

Figure 5-6. Gravity Levelled Rubber Around Island Blocks Completed and "C" Clamps Removed

The front spar tool was completed during the month of September. Figures 5-1 through 5-8 show the procedures used to pour and cure the rubber parts of the tool. Figure 5-1 shows the positioning of island blocks used to mold the rib attach angles and stiffeners on the tool base plate. Figure 5-2 shows the dummy web being fitted inside the tool cover on the flat island blocks that form the flat side of the web. Figure 5-3 shows the waxed island blocks. Waxing is the technique used to fill in the gaps between the room temperature rubber and the dummy parts. Dummy parts are made to the nominal thickness of the finished part. Prepreg laminates are thicker than cured laminates and the rubber is required to be set back from the laminate to allow for expansion of the rubber with increase in temperature before applying pressure to the part. In Figure 5-4, rubber is pumped into the lowered upper end of the tool cover to form the rubber blocks used to mold the forward cap flanges to spar web intersection. Rubber is mixed, degassed, and pumped into this cavity using an automatic rubber mixing machine. Figure 5-5 shows the rubber emerging at the raised end of the tool which is approximately 25 feet from the point where the rubber is pumped into the tool. The island blocks shown in Figure 5-1 have been turned upside down to fit into the tool cover shown in Figure 5-2. The base plate is removed exposing the cavities between the island blocks. Figure 5-6 shows the completed pouring of rubber around island blocks. After partial cure, the island blocks are removed as shown in Figure 5-7 and the rubber is cured in an oven as shown in Figure 5-8.
